Fertilizer Plant

Hoopstad, Freestate
South Africa
January 2025

Due to the high PH content of the fertilizer stored in the building, the steel structure requires continuous maintenance to combat corrosion and degradation.

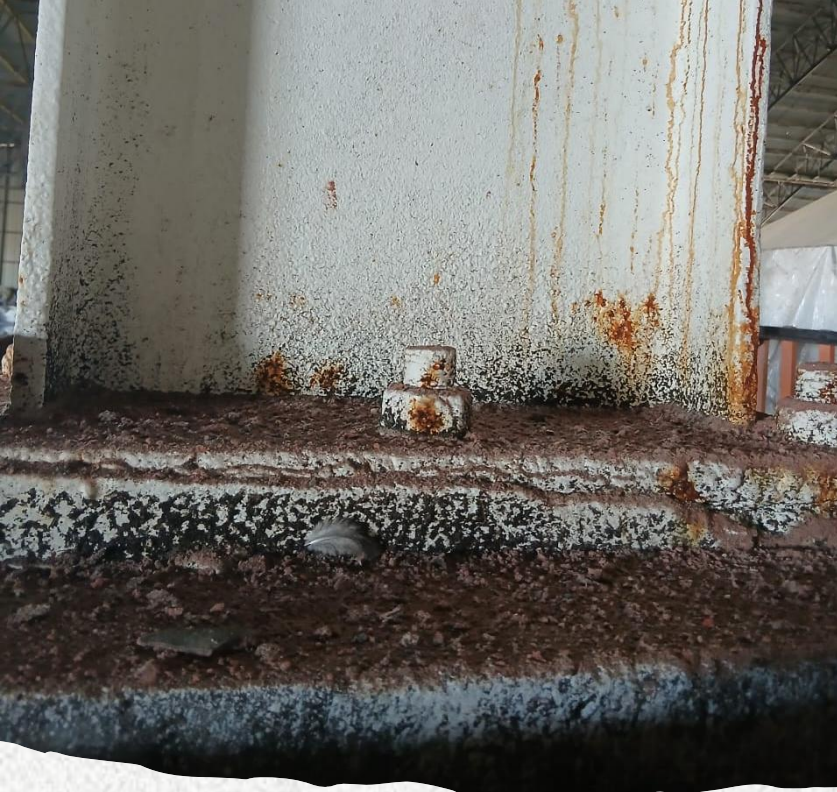
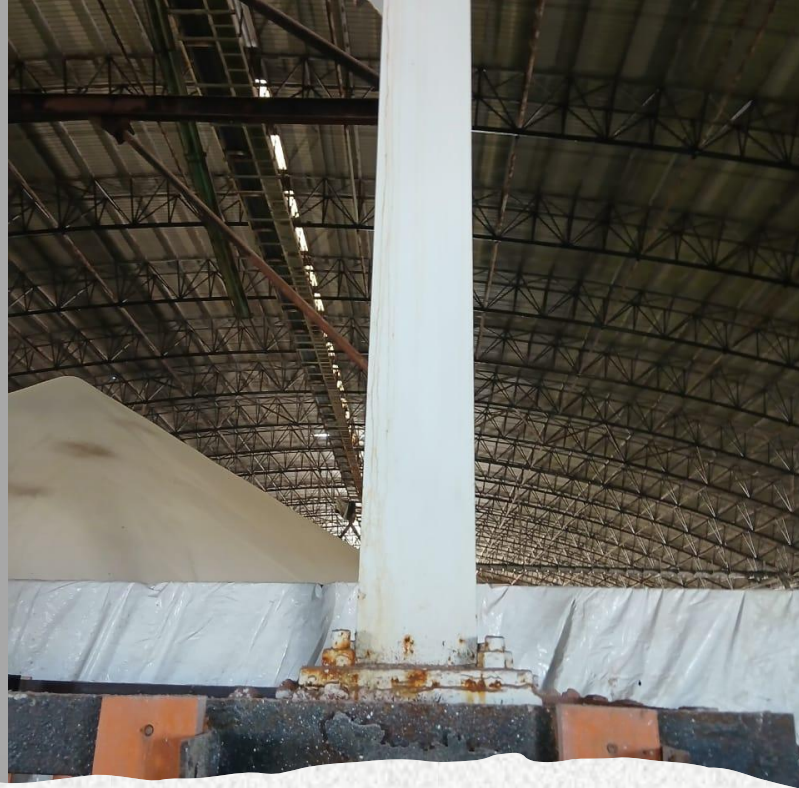
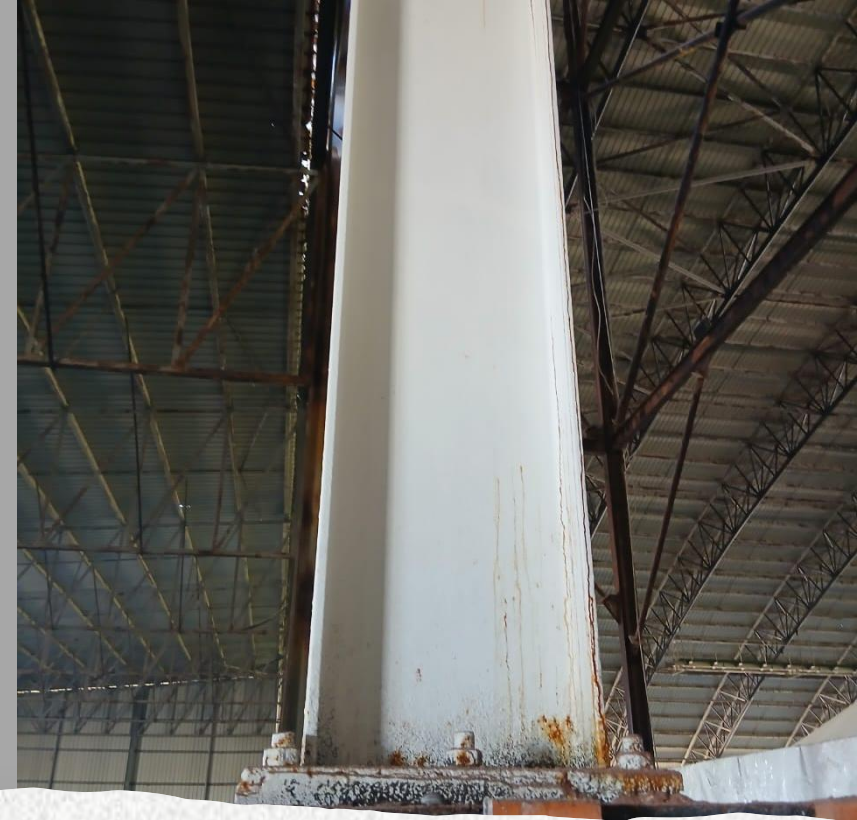
A portion of the pillars were prepared and coated.

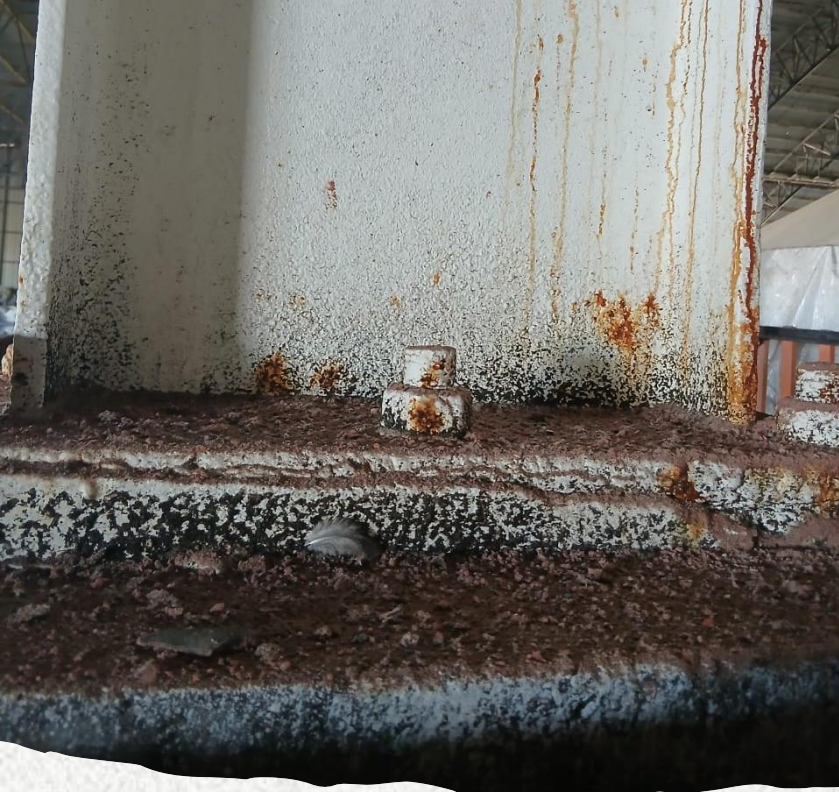
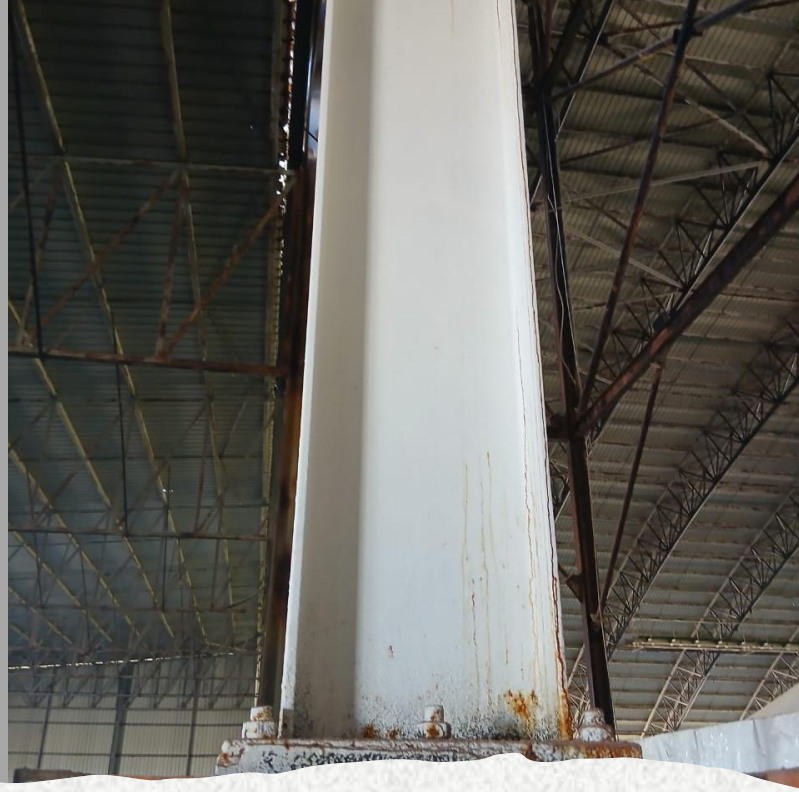
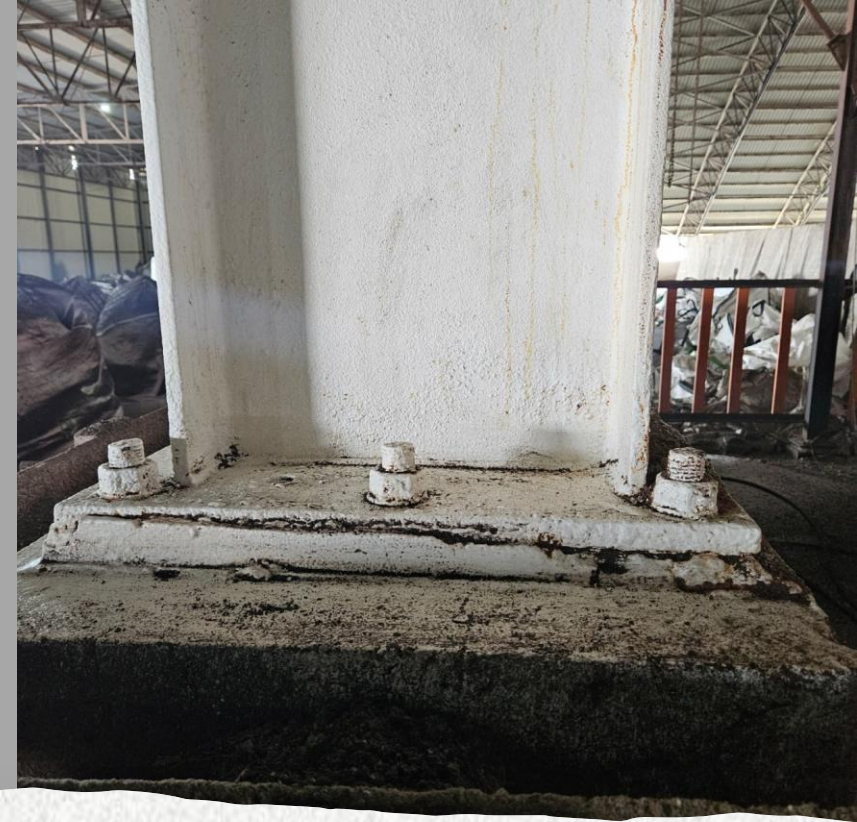
3 Months After Coating

Discolouration was found at the base of the pillars after the 3 month period.

Discolouration was caused by corrosion dripping down the pillar and collecting at the base of the column, and in rough patches where previous corrosion had eroded the steel structure.

As can be seen above this was just surface discolouration and was easily removed with a damp cloth.

A full investigation is required to ascertain the cause.

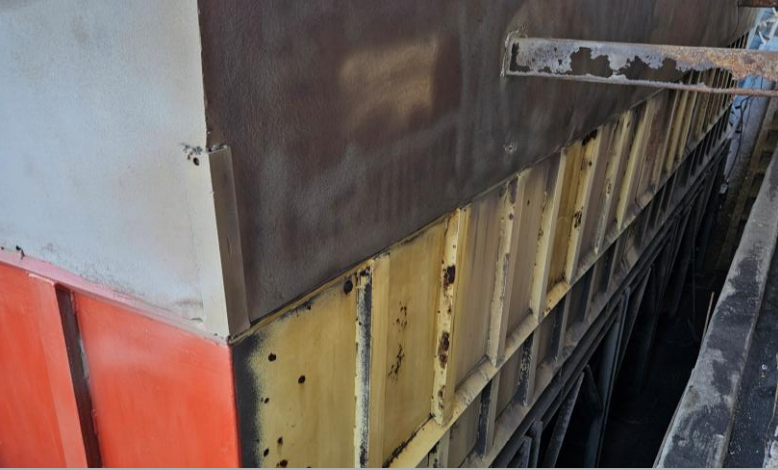
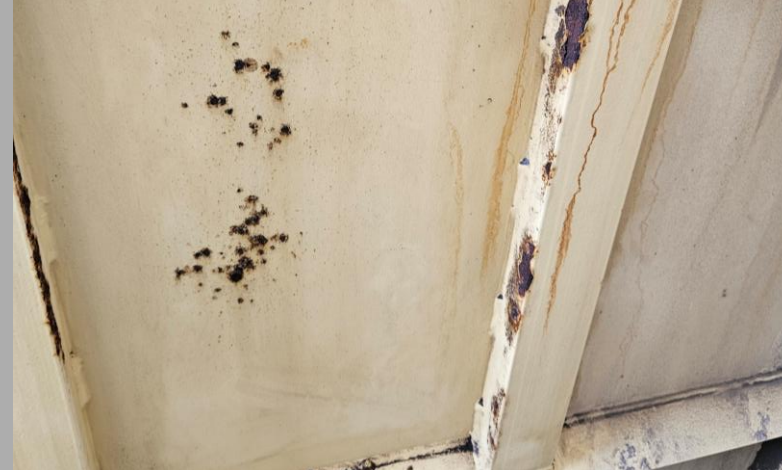
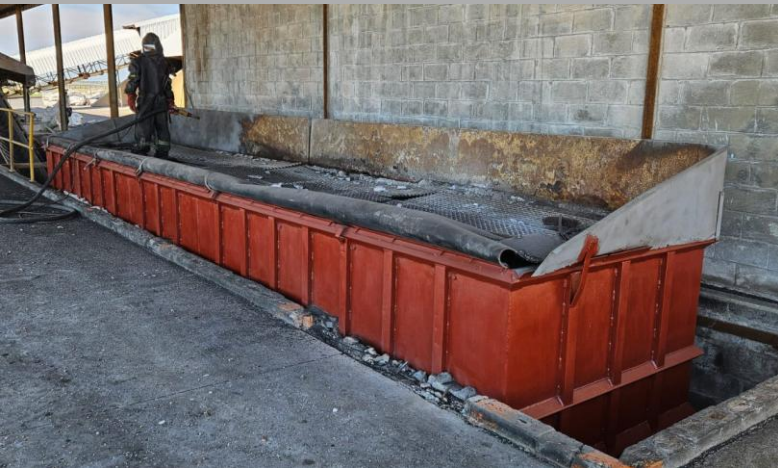
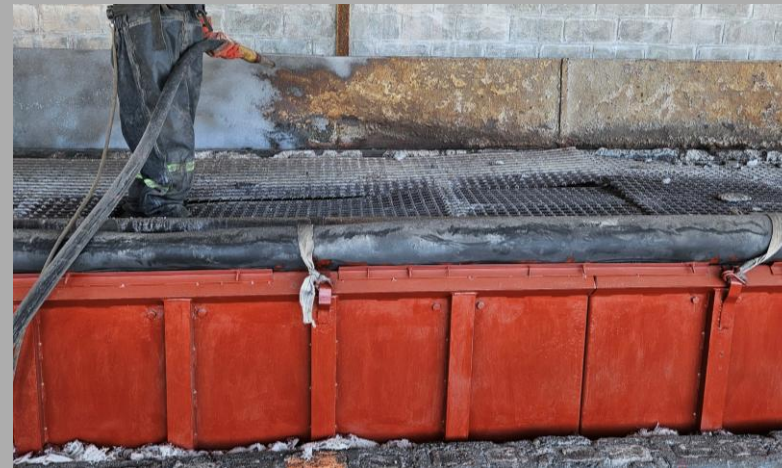
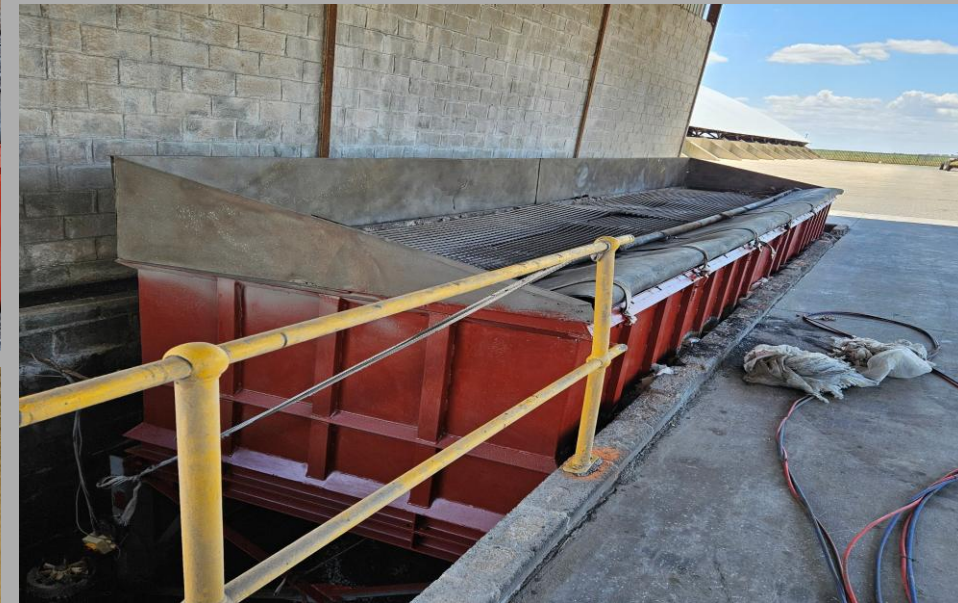
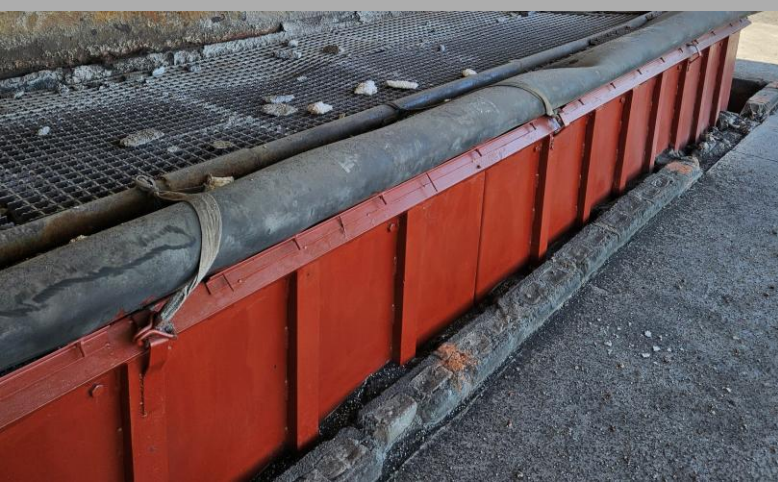
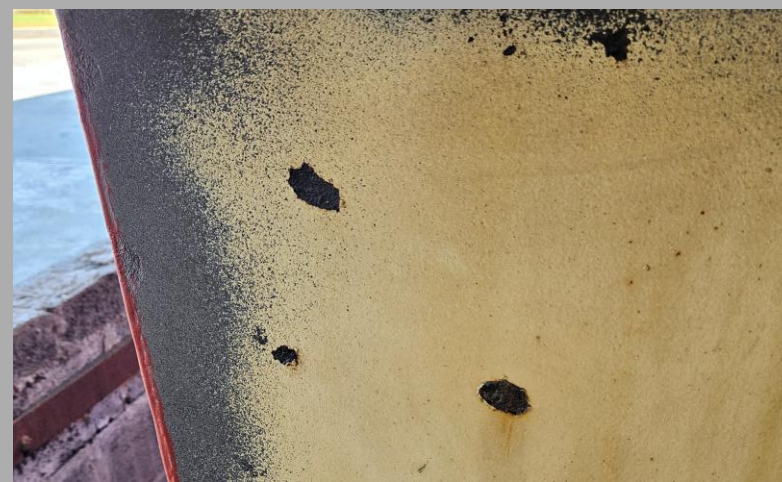
The Hopper was an area of concern due to corrosion degradation.

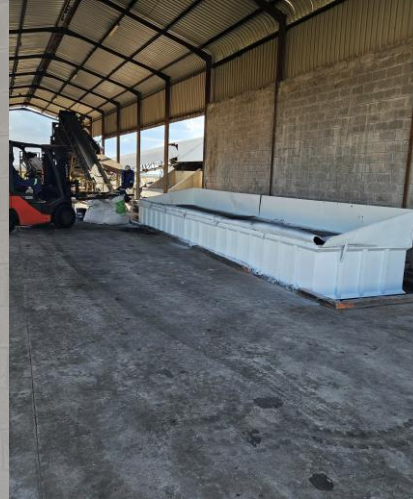
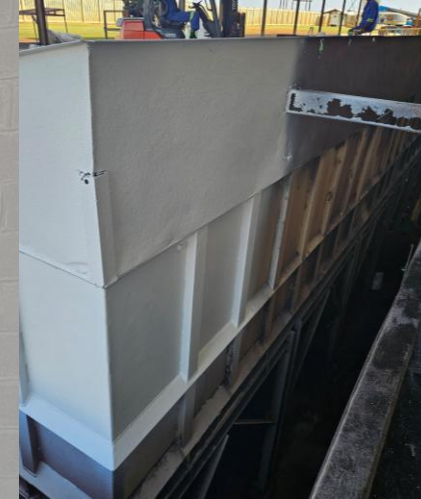
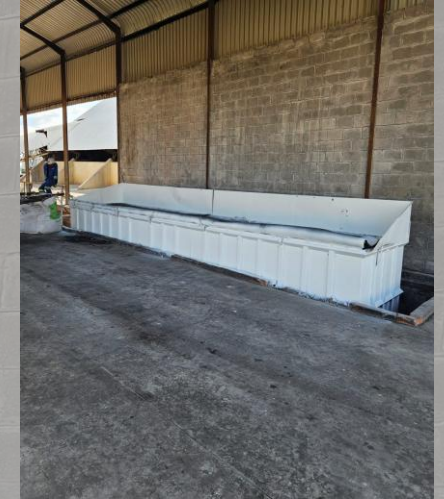
Most of the Hopper was blasted and painted with red oxide in preparation for the coating of SI-COAT 579.

Preparation does not require red oxide. The corroded areas can be cleaned with a flap wheel or wire brush before coating.

The client had already begun painting the red oxide, which we had not requested. We demonstrated on the areas not painted with red oxide but just sand blasted, that SI-COAT 579 could be applied directly onto the surface without a primer. The client was impressed that after 3 months there were still no signs of corrosion.

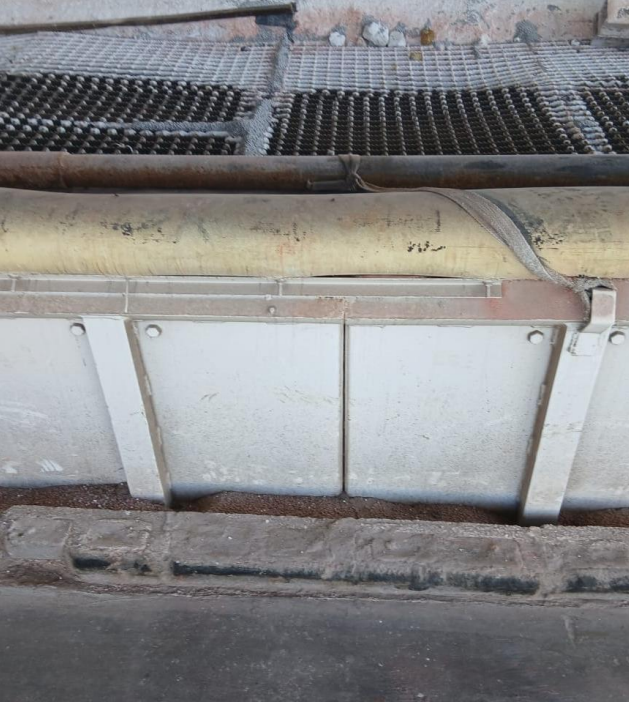
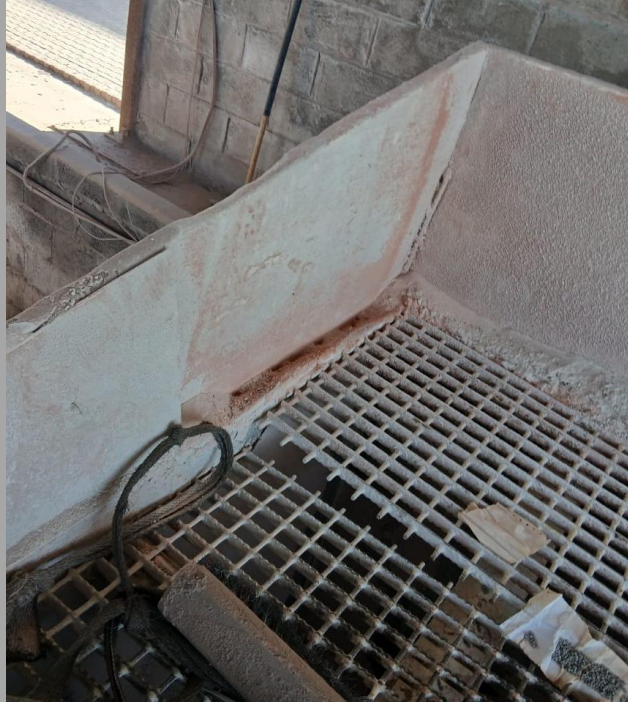
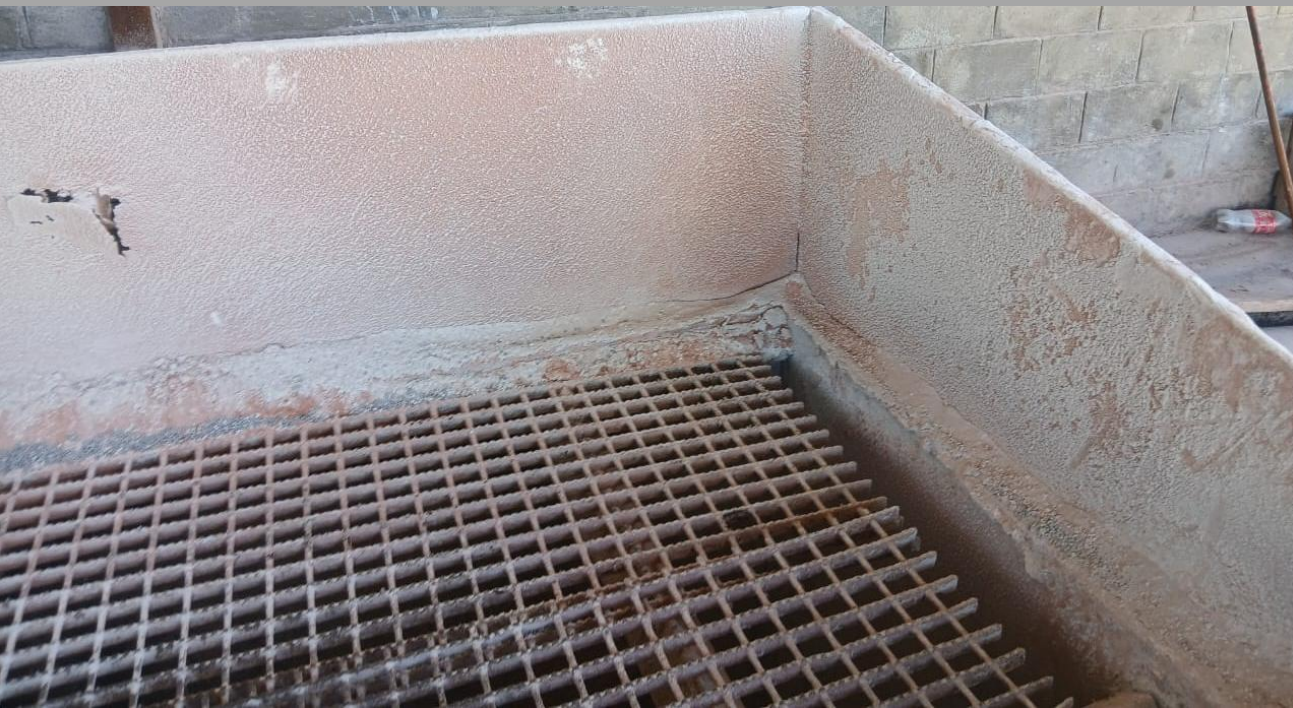
3 Months After Coating

After 3 months the Hopper showed no signs of corrosion where SI-COAT 579 was applied.
