Concrete Mixer

**Métier**
MIXED CONCRETE

Technical Solution
Supplies

Product Test

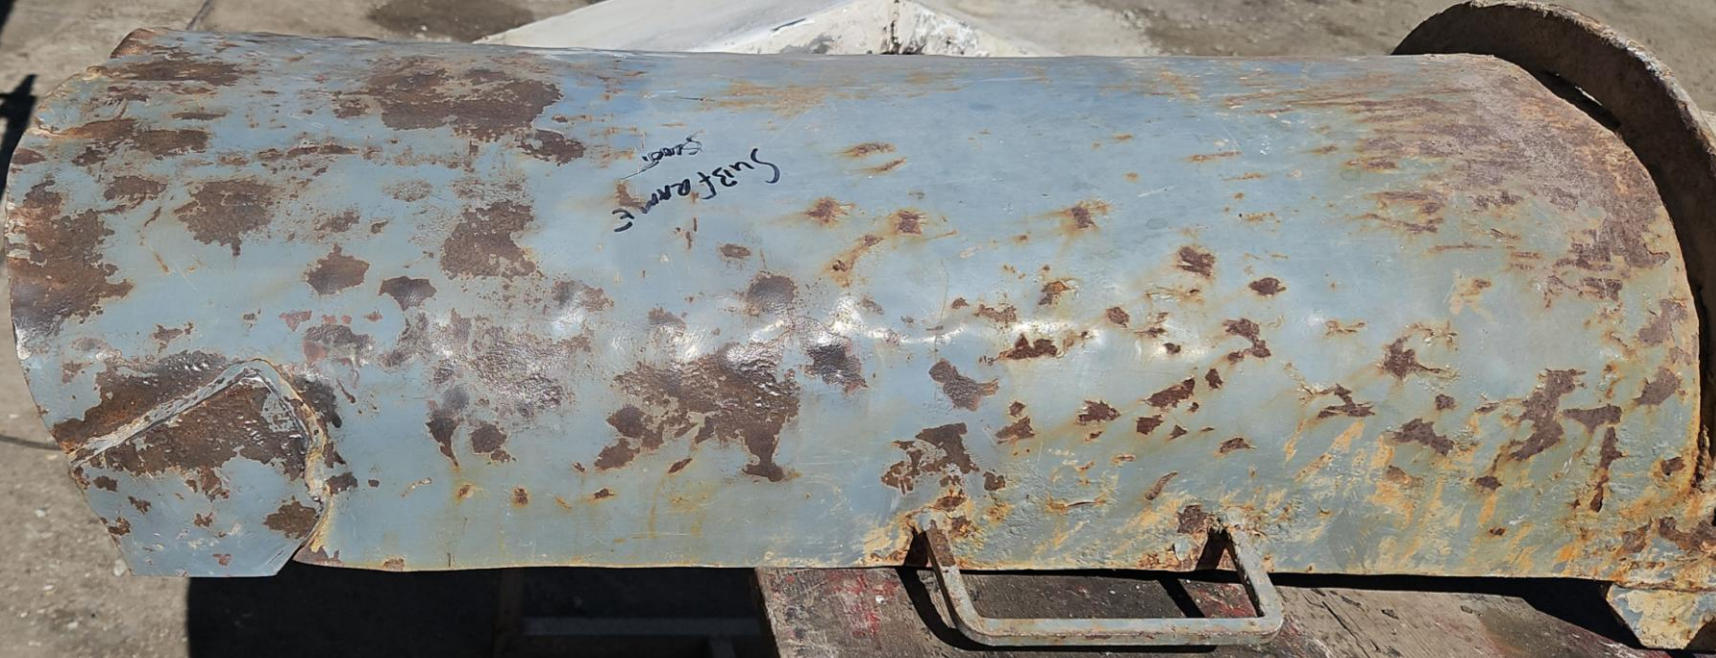
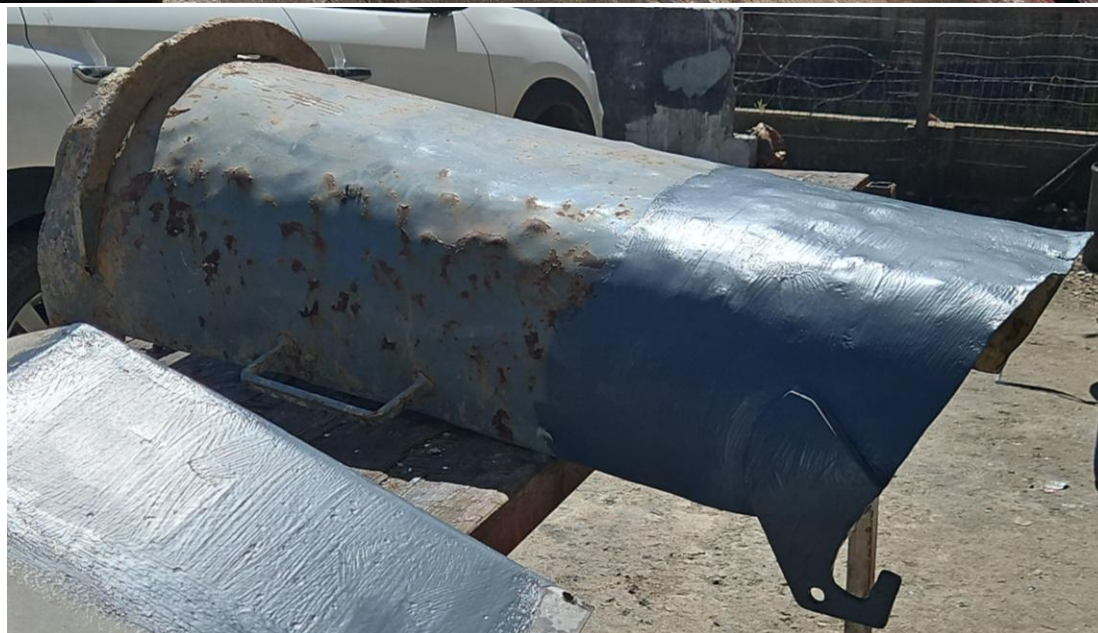
- **Hardening of concrete** especially around the Hopper area.
- Hardened concrete **removed** by **impact tools** and/or acidic water mixture.
- These processes **damage** the **coating** and structures on the concrete trucks.
- **Maintenance costs** are **high** due to regular cleaning and repainting of the concrete trucks in these areas.

Picture of Impact Damage

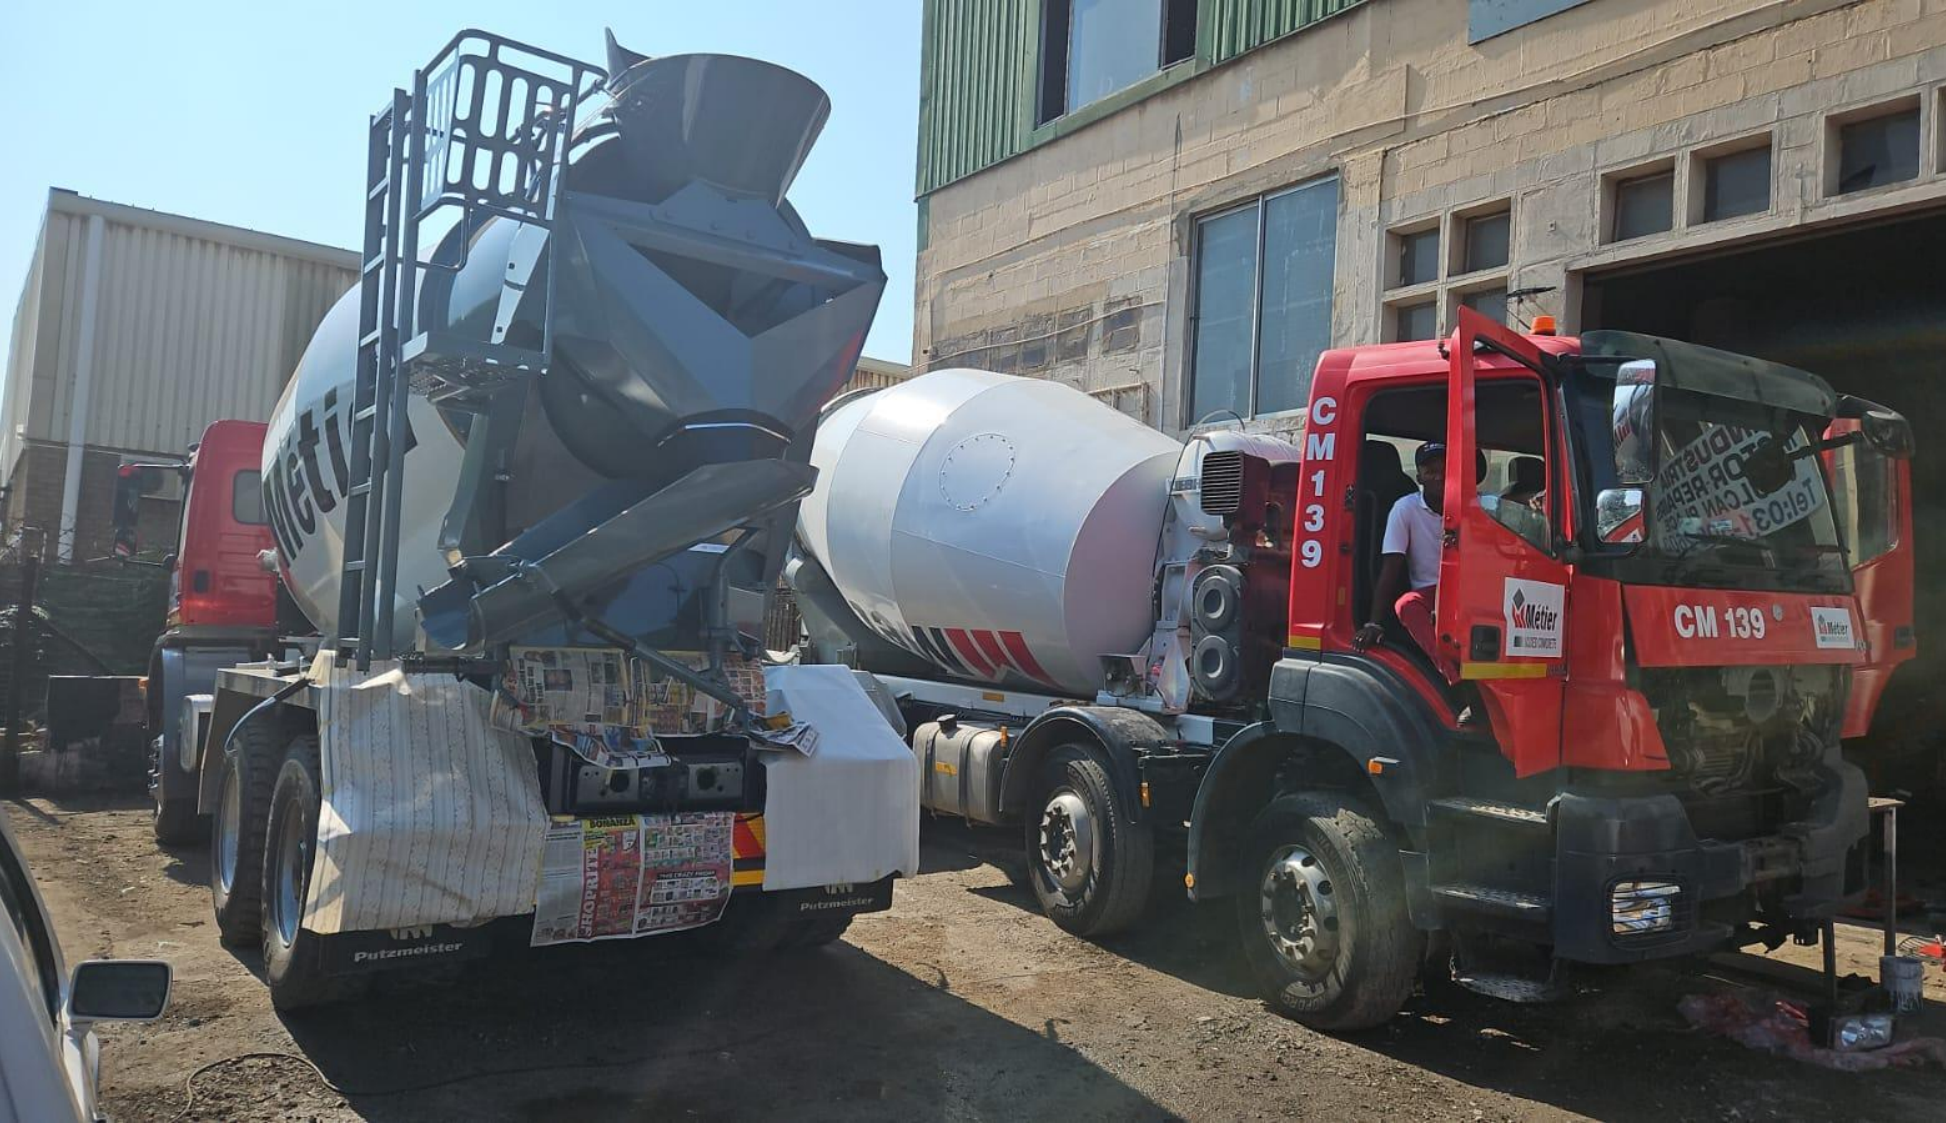
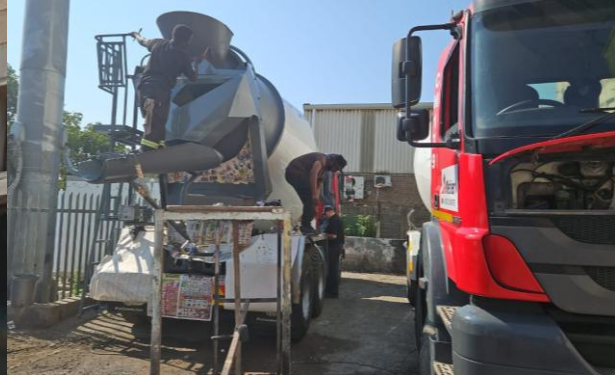
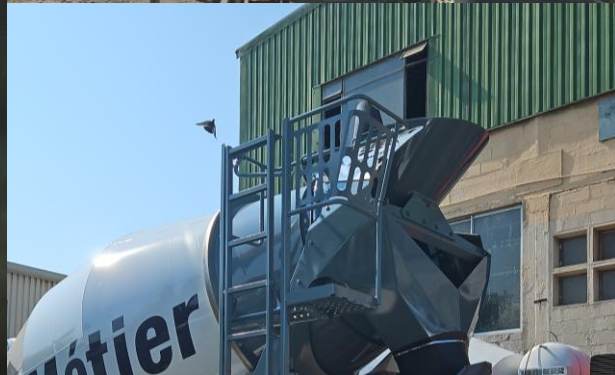
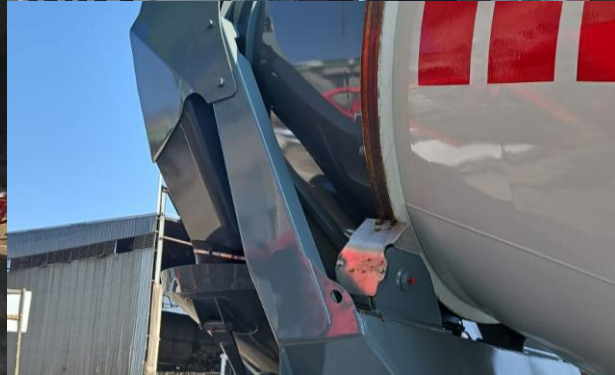
Damaged Trough Test

- Ease of application
- Acid resistance
- Concrete adhesion resistance

SI-COAT 579

After the successful test of the damaged trough the application of SI-COAT 579 was applied to the hopper end of the concrete mixing truck.

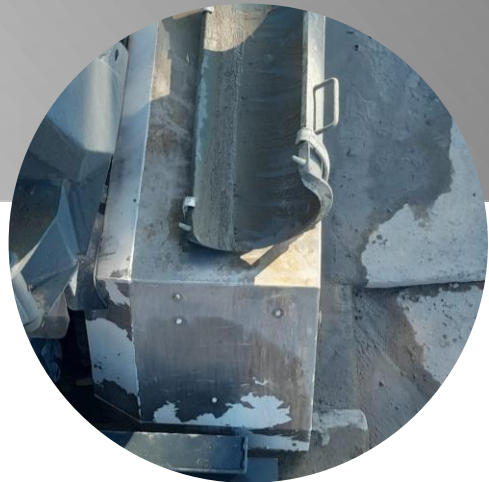
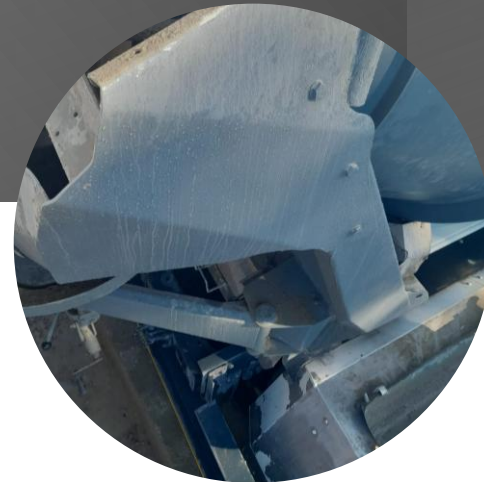
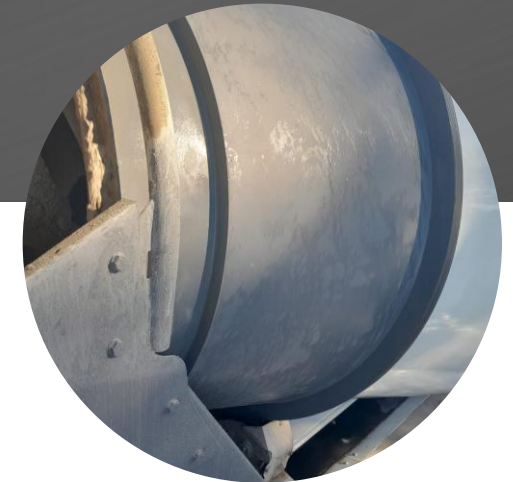
3 Weeks After Coating

After 3 weeks it was clear to see that there was no concrete adhesion to any parts that were coated with silicone coating SI-COAT 579.

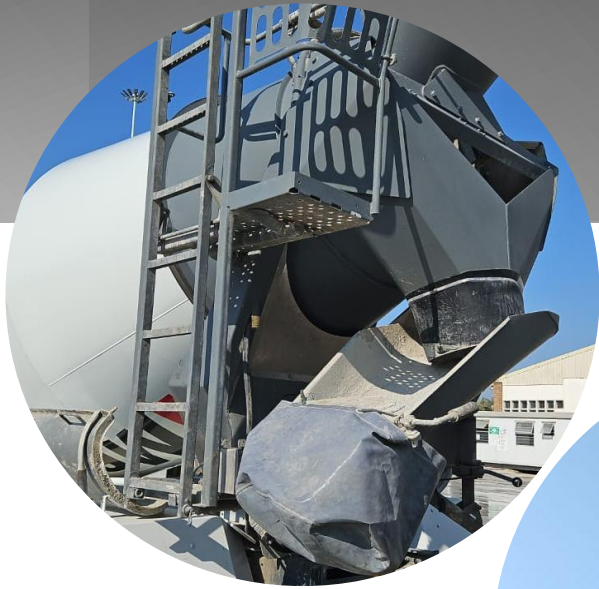
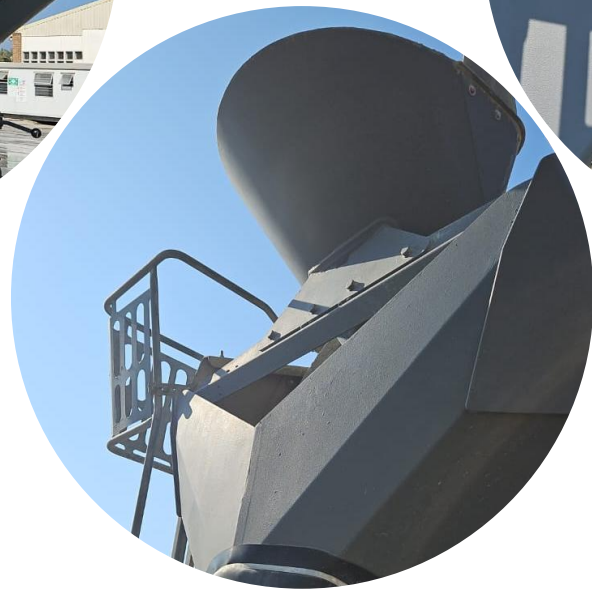
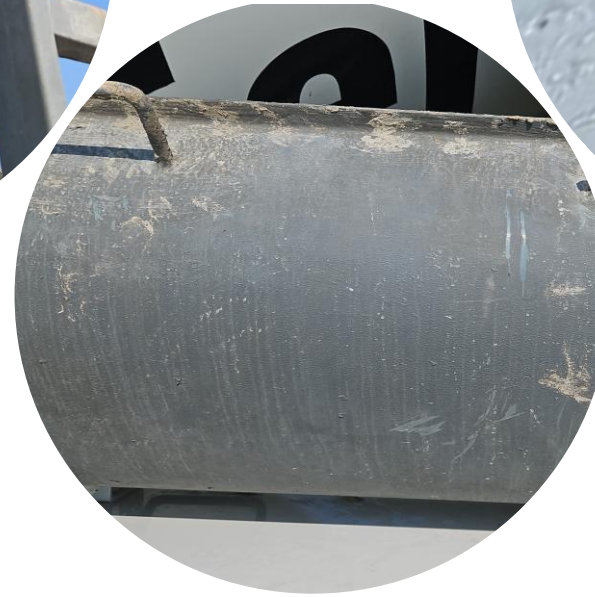
12 Weeks After Coating

After 12 weeks of continuous work no clear damage could be seen on the coating due to the concrete. There were no visible signs of hardened concrete other than on the outside of the trough, and this was easily removed with a high-pressure cleaner.
