# Corrosion Maintenance

## COATINGS

Si-Coat® CM – Corrosion Maintenance Coating

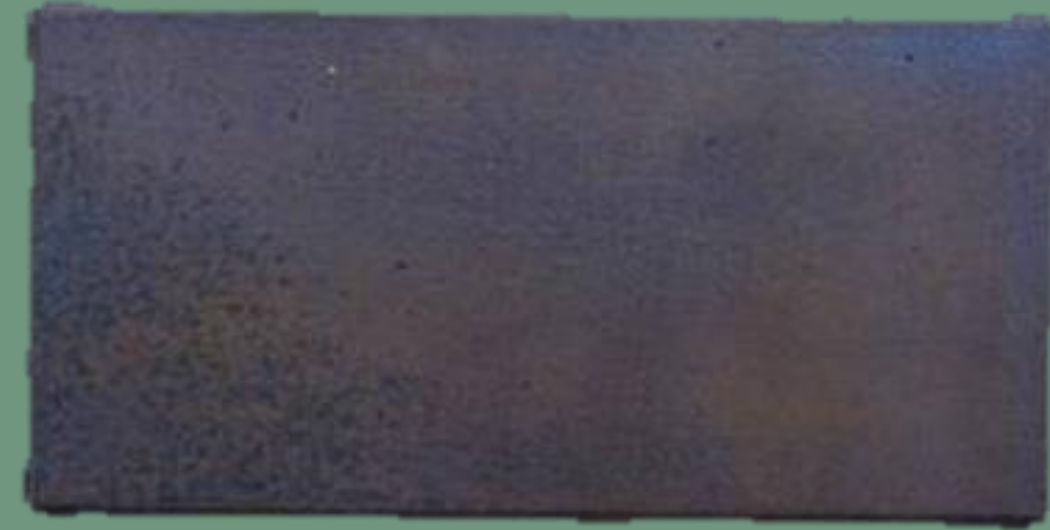
## PREPARED TO SSPC-SP2 STANDARDS

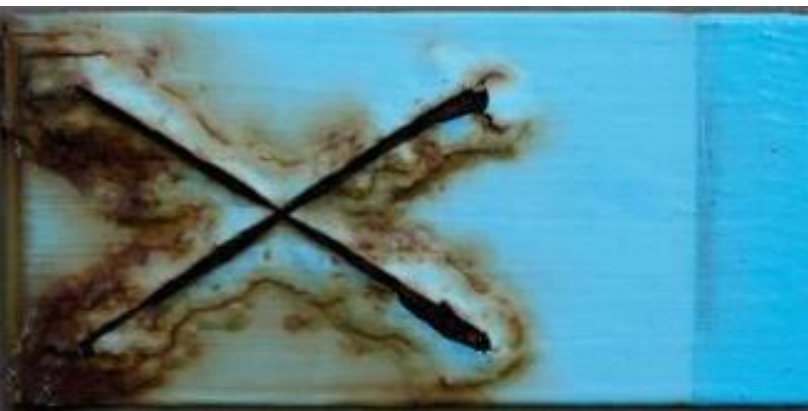
EPOXY

**Epoxy three-coat (IOZ/epoxy/PU) system on abrasive blasted steel:**  
heavy corrosion creep and corrosion bleed-through, with adhesive failure

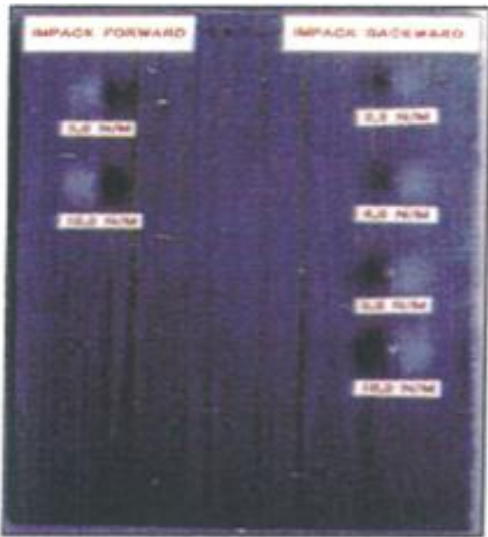
Figure 2: SI-COAT applied over TCP shows no damage upon impact testing, and bridges all cracks of the underlying TCP

CSL coating produces excellent results on old TCP coating with regards to resistance against mechanical damage. During the impact resistance test the TCP coating cracks, but the CSL coating applied on top of it bridges these cracks.

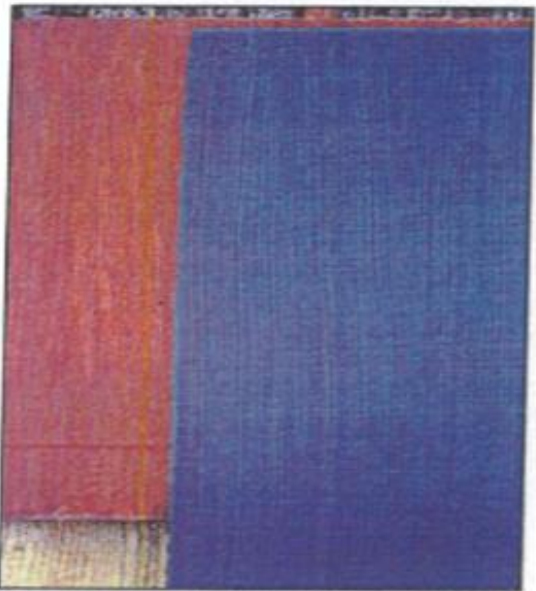
Figure 4: Cleaning with high pressure water at 100 bar shows no damage to Si-COAT

Up to 100 bar the CSL coating can be cleaned without problems.  
At pressures above 150 bar, problems can occur.

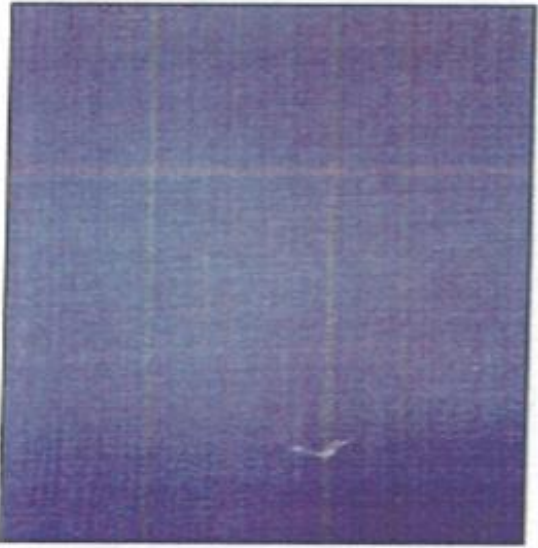
Figure 5: Cleaning with high pressure water at 200 bar begins to show slight damage to Si-COAT

| Cleaning test | 50 bar no damage<br>100 bar no damage<br>150 bar no damage<br>200 bar damaged coating |

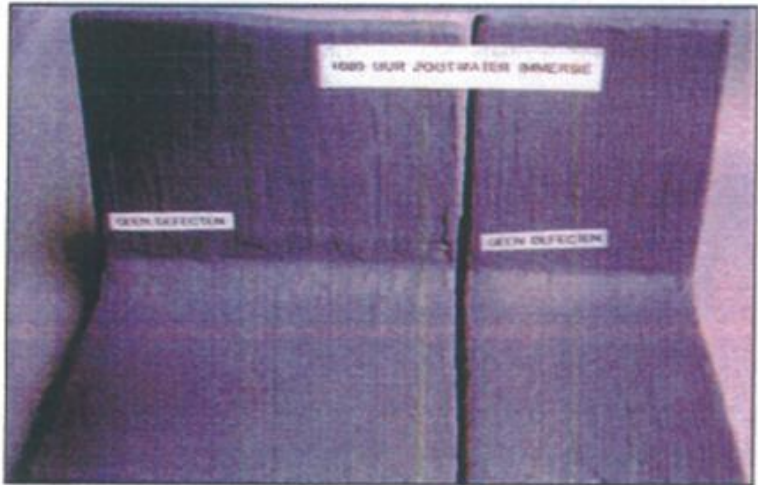
Figure 9: After 1,000 hours of salt water immersion, Si-COAT shows no damage

| Salt water immersion | After 1,000 hours immersion in a 5% salt solution the CSL coating shows no damage |

CSL coating is fit for use in salt water.

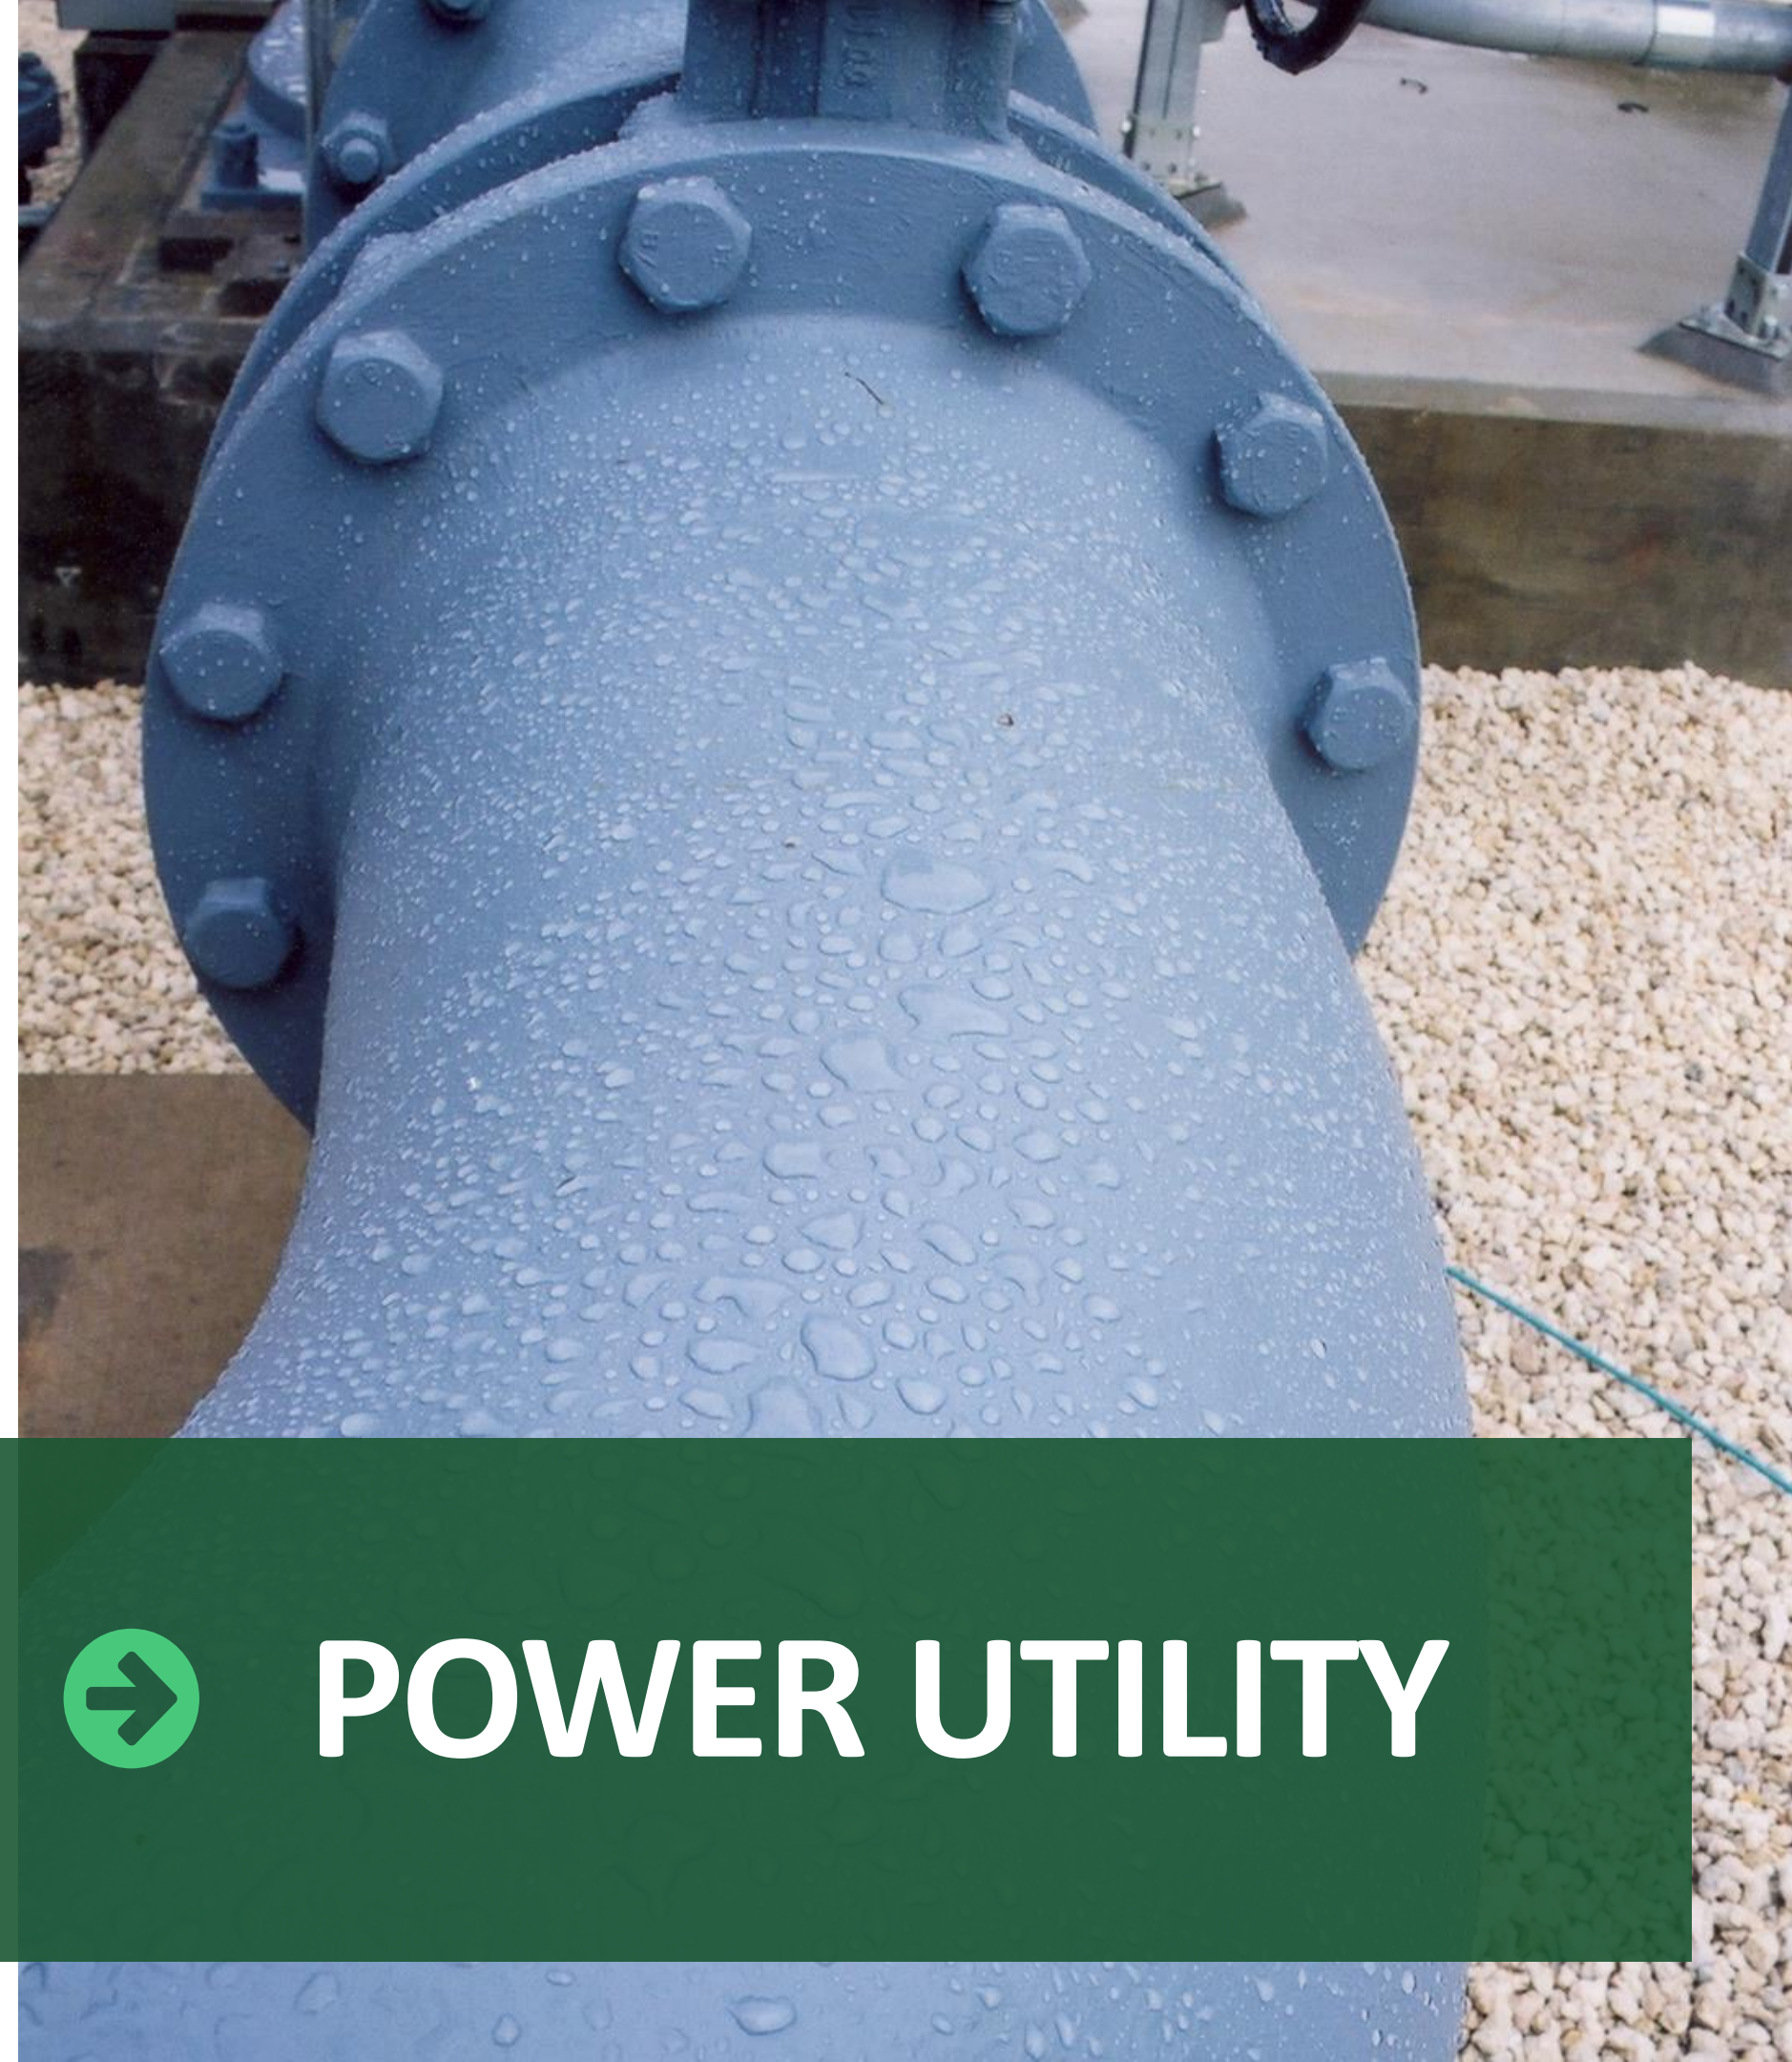
# 1.0 Case History

Solves Widespread Corrosion Issues on 10-Month Old OEM Pipe Coating

It's what nightmares are made of for corrosion engineers – the 15 miles of newly ordered process piping begins to show widespread breakout rusting in less than ten months of service. Sounds like a headache? It's exactly the scenario faced by the Lead Corrosion Engineer of a major Florida, USA power utility.

**Figure 1: Heavy rusting around welds were cleaned by power tools to tightly bound rust**

To prepare the piping for Si-COAT, water blasting at 5,000 psi (352 kg/cm<sup>2</sup>) with a turbo tip was all that was used for a vast majority of the piping. The weld joints, all of which were very heavily rusted, were prepared to the SSPC-SP3 standard by power tool cleaning of all rusty areas followed by a solvent wipe down. All surfaces, whether blasted with water or power tool cleaned, were brought down to tightly bound rust.

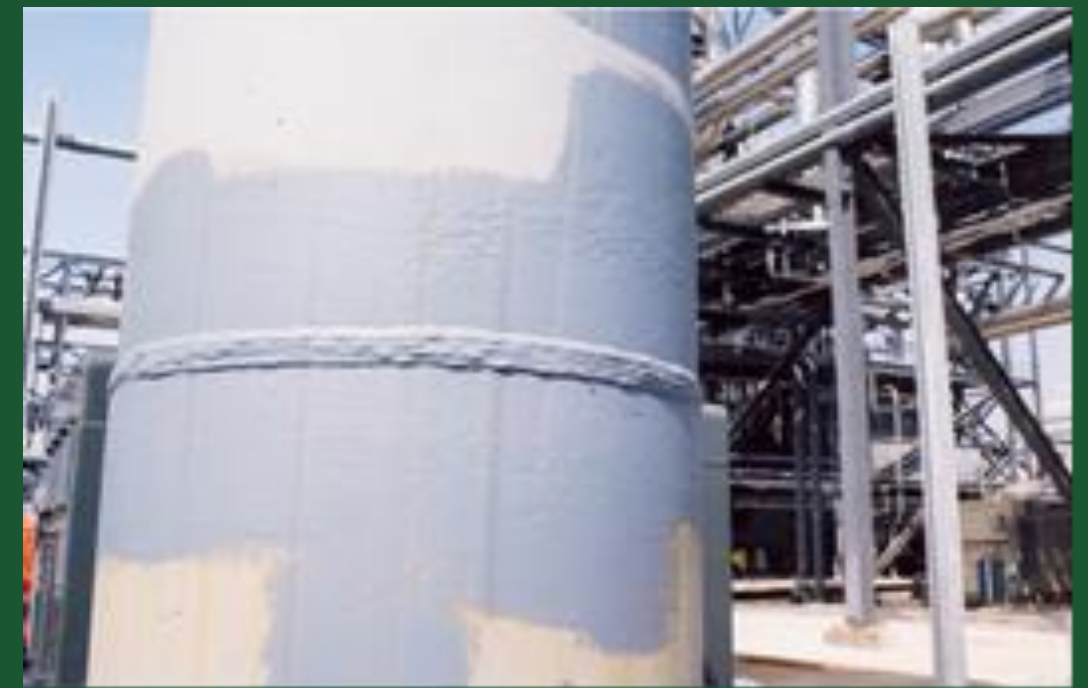
**Figure 2: Weld joints were spot primed with Si-COAT 579 for added protection**

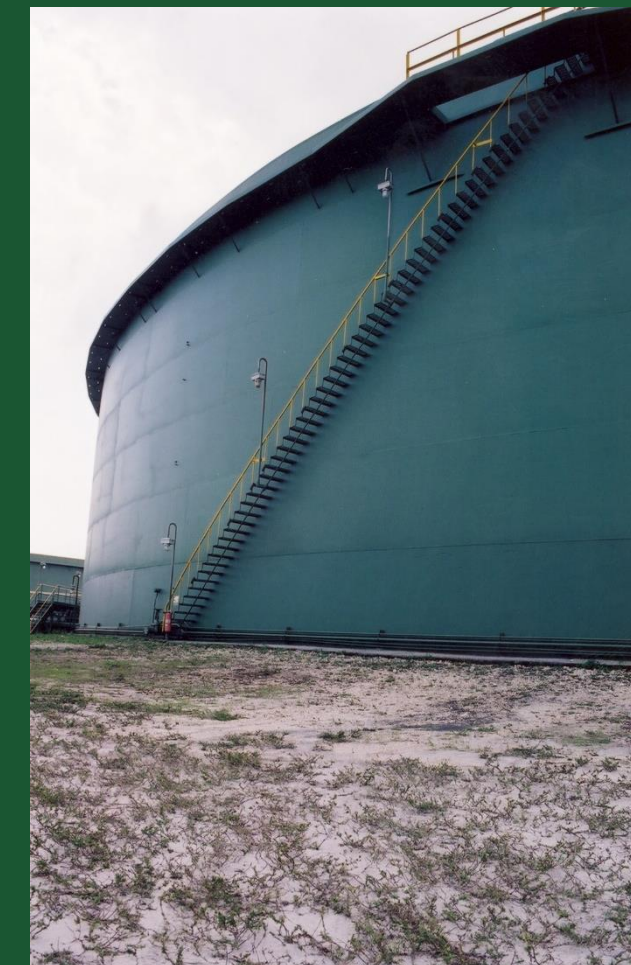
## After three years of testing:

Primerless,  
one-coat Si-COAT  
579 AC system  
applied directly to  
rusted steel.

Comparatively, the Si-COAT coating showed no corrosion creep and no bleed-through rusting or discoloration. The coating did collect salt spray residue that was easily wiped away to reveal no loss of color or gloss.

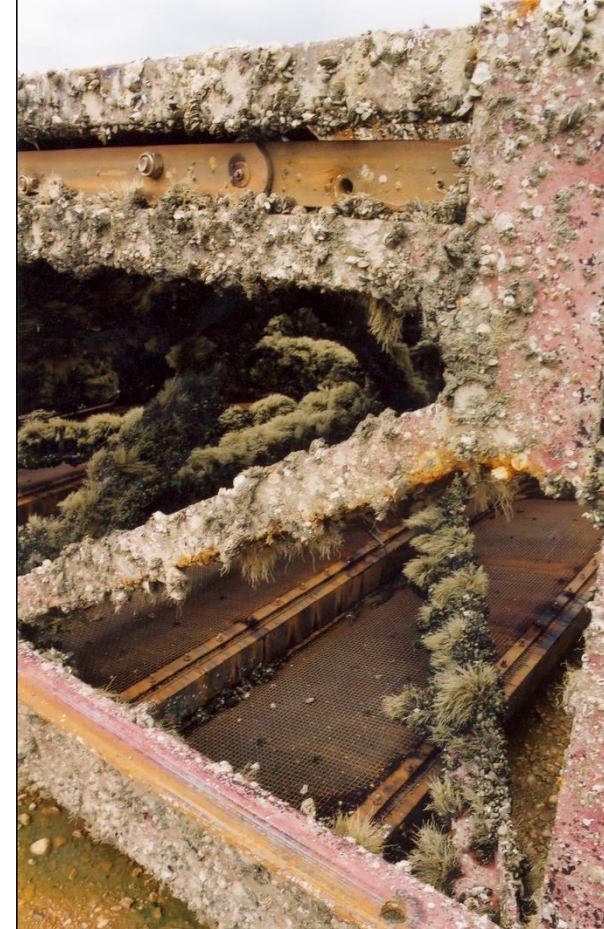
BEFORE

Epoxy coatings failing within three years; heavy corrosion at splash zone; marine growth impeding equipment operation

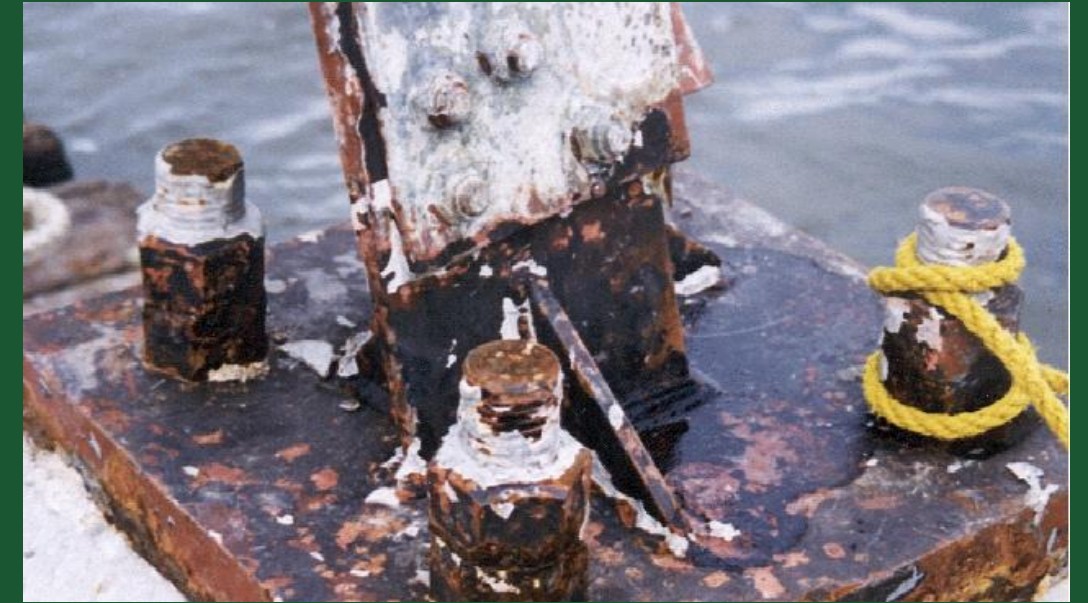
Figure 1: A representative state of the galvanized steel from which other coating were repeatedly applied on a 12-month cycle

Corrosion control and tower maintenance had been an ongoing battle for Reliant Energy, one of the largest utilities in the United States. Their efforts were wasted in using conventional, supposed 'high performance', coatings based on epoxy or alkyd technology. With use of those products, their budgets were being overrun due to frequent product replacement (i.e. short service life) and personnel were experiencing health issues because the epoxy mastics required hand application.

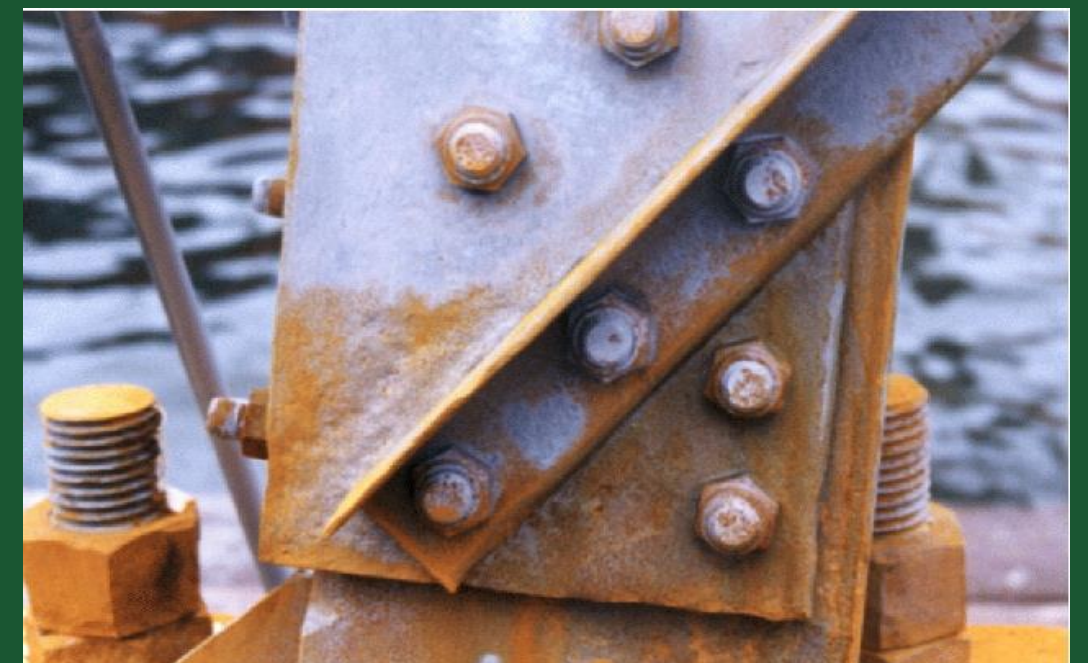
Figure 2: A tower leg ready for application of Si-COAT 579 after surface preparation by hand using wire brush and solvent wipe

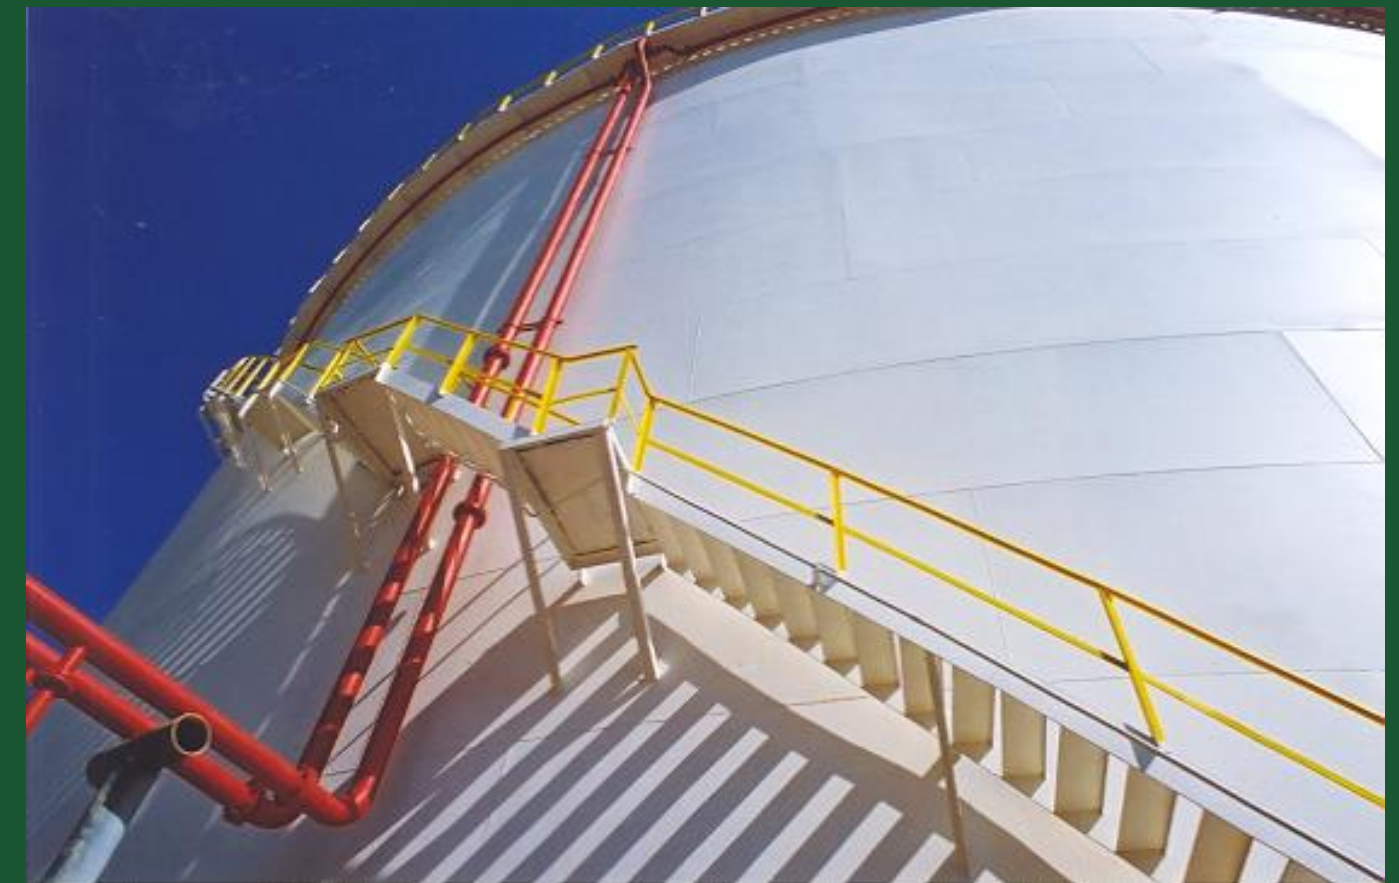
Despite the severe conditions of the tank, surface preparation required only a pressure-wash at 11,600 psi (800 bar). The average waiting time between pressure-washing and application of Si-COAT was one day. In total, the project consumed 706 US gallons (3,200 kg) of Si-COAT 579 at a dry film thickness (DFT) of 14 mils (350 microns). The coating was applied in one single coat.

The benefits, both economic and otherwise, were immediately obvious and undeniable. Due to Si-COAT's elimination of abrasive blasting, the local population was entirely unaffected by the project. But perhaps even more striking, because Si-COAT could be applied in a single coat after a simple pressure-wash, the project timeline and size of the crew were greatly reduced compared to the application of a conventional coating system. This saved labor dollars and allowed the tank to be put into service much more quickly. As well, because abrasive blasting was not required, hot work precautions were unnecessary. The duration of the project was only 12 days from start to finish, with a crew of only 6 people. From previous experience in coating tank P-701C and other identical tanks in the tank farm, use of a conventional coating system would have required 16 people working for 42 days. This translates to 720 total working hours with Si-COAT versus 6,720 total working hours with a conventional coating system.

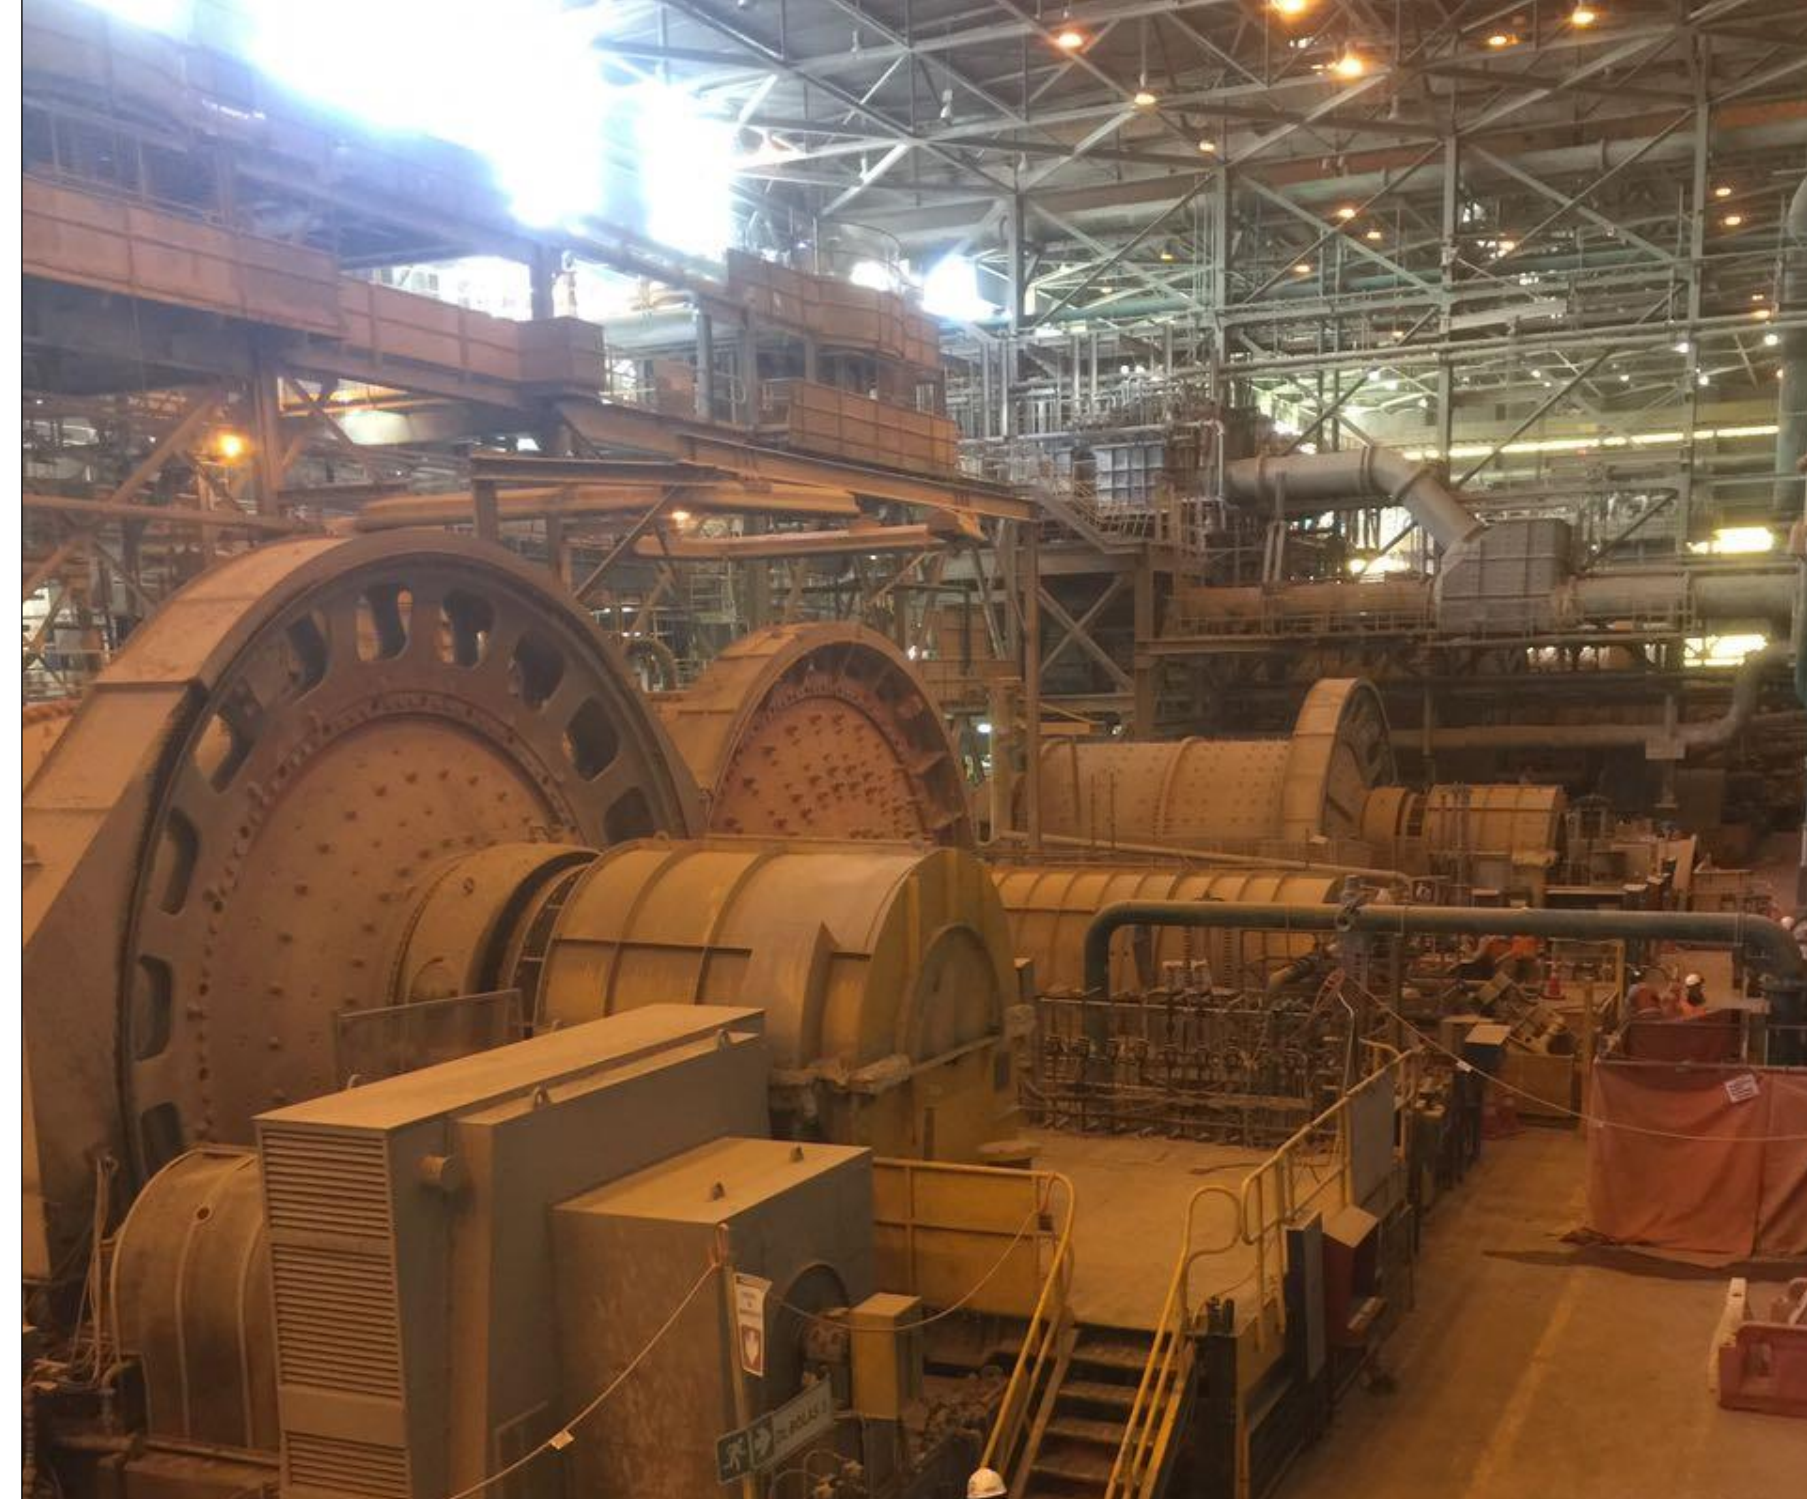
Si-COAT®'s surface preparation has simple requirements: ensure that the surface is free of oils, resins, dust or any loose pre-existing coating. Any salt accumulation over top of the coating or metal also needs to be removed. To do so, Si-COAT® only requires SSPC-SP1 – solvent cleaning. After the surface preparation was completed, Si-COAT® was applied and successfully adhered to the epoxy and any exposed metal.

The application of Si-COAT® 579® AC in Tennis Court Green was done primarily using airless spray and brushing in areas that were difficult to access. Nexo, the application contractor, was supervised, inspected and advised by CSL Silicones on the best practice and methodology to apply our Si-COAT® 579® AC Corrosion Maintenance Protective Coating. All in all, surface preparation was minimized, and our customer's cost efficiencies were maximized.

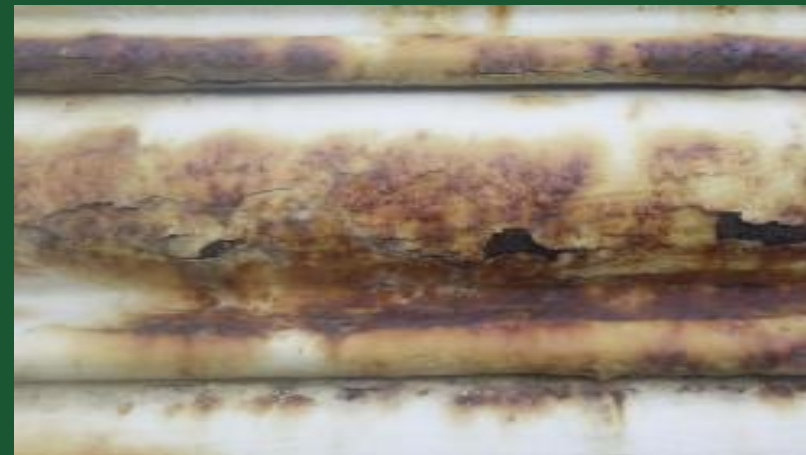
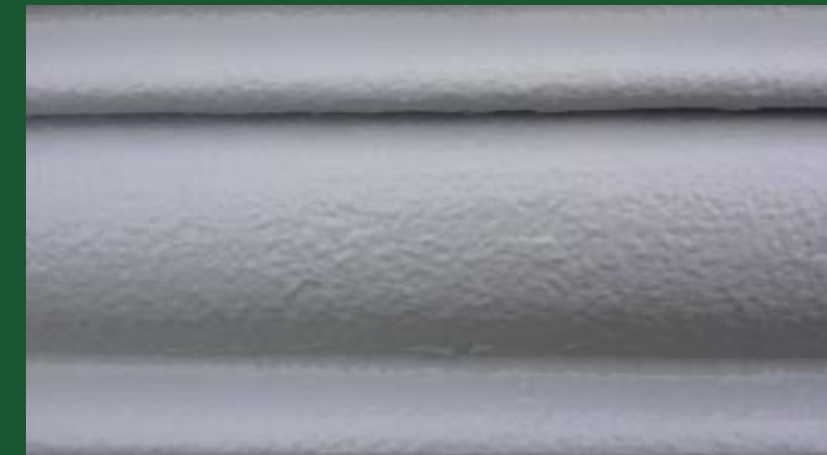
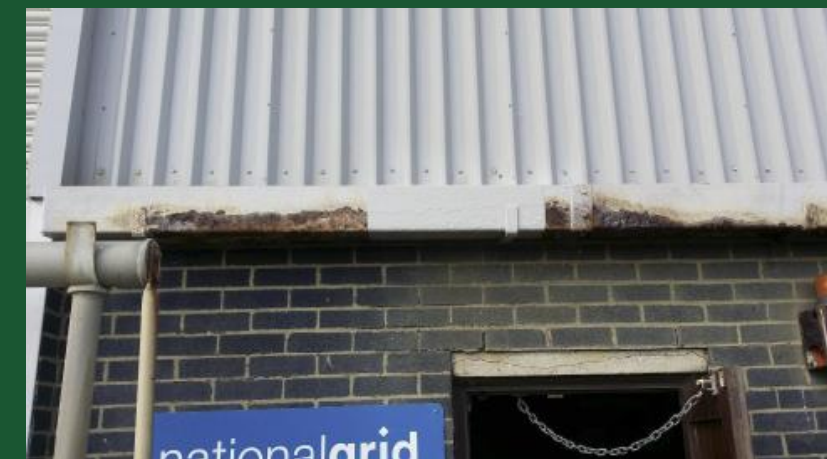
The application was successful, and it is expected that the coating will provide good results in this extreme environment where the metalwork is heavily corroded.

The RTV silicone coating at the test locations will be monitored and inspected after 1 year by CCS to check the condition and if any rust creep has occurred.
